ALKALI SILICA REACTION (ASR) POTENTIAL OF SAND AND GRAVELS FROM NW-HIMALAYAN RIVERS AND THEIR PERFORMANCE AS CONCRETE AGGREGATE AT THREE DAMS IN PAKISTAN

Key words: Aggregates, Concrete, Alkali – Silica Reaction, Dams

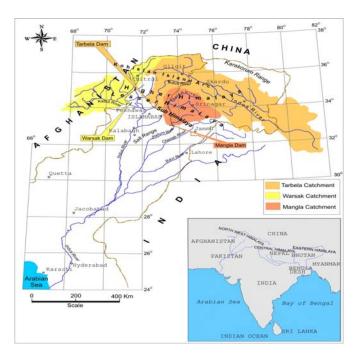
Fig. 1: Location of Tarbela, Warsak and Mangla dam with their respective catchments in NW Himalaya

The catchment of Mangla dam occupies the Jhelum, Neelum, Kunhar and Poonch rivers. The Kunhar and Neelum rivers flow through Higher Himalaya, Lesser Himalaya as well as Sub Himalaya where they join with the Jhelum river. The Poonch river drains Lesser and Sub Himalayan terrain. The Jhelum River itself originates from Lesser Himalaya. However upstream of Mangla dam 120 km stretch of the river flows in sub Himalayan terrain. The geological domains through which these three rivers flow have been shown in the Fig. 1 and 2.

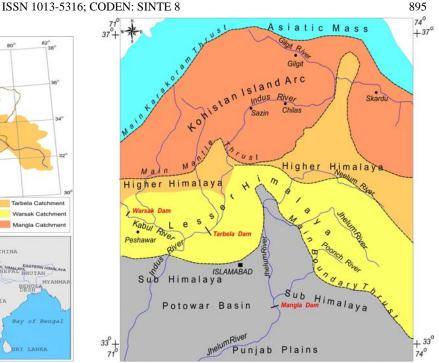
Fig. 2: Geological Subdivisions of NW Himalayas

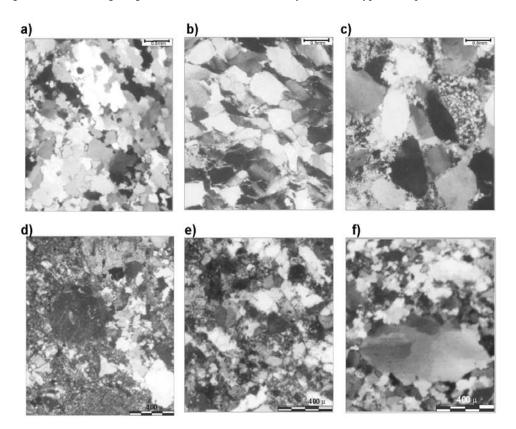
Figure 4: Photomicrographs of some of the reactive rock types a, b) quartzite with stained quartz c), greywacke with microcrystalline matrix in Jhelum River originating from Lesser Himalaya d), acid to intermediate volcanics with glassy to microcrystalline matter e), greywacke f), granite from Higher Himalaya with highly strained quartz

The northwest part of Himalayas forms the leading edge of Indian plate. The area represents the mountain chains, suture zones representing many large scale thrust faults (i.e, Main Mantle Thrust and Main Karakorum Thrust) due to Indian and Eurasian plates' collision. Geographically the area occupies a large part of the State of Jammu and Kashmir, Northern Pakistan and some part of Afghanistan as shown in Fig. 1 and 2. The rock types exposed in various geological subdivisions of Northwest Himalayas are as shown in Fig. 3. Photomicrographs of some of the rock types are shown in Fig. 4.
